Residential Development at Crodaun,  
Celbridge, Co. Kildare

Stage 1 Road Safety Audit

Ardstone Capital Ltd

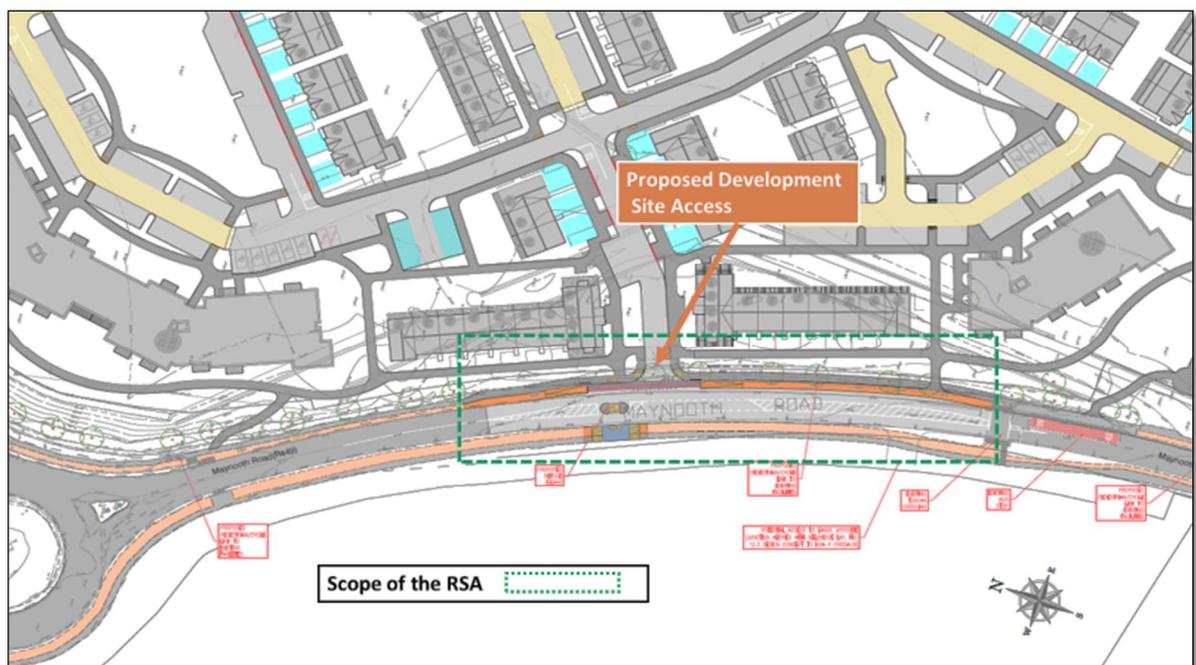
Figure 1.3: Geographical Scope of Road Safety Audit  
(Extract of Entrance Junction General Arrangement Drawing, DBFL)

1.1.4 The geographical scope of this road safety audit considers the proposed residential developments new site access junction (Three arm priority-controlled ghost island arrangement) on the R405 Maynooth Road and its immediate approaches as illustrated in Figure 1.3 below.

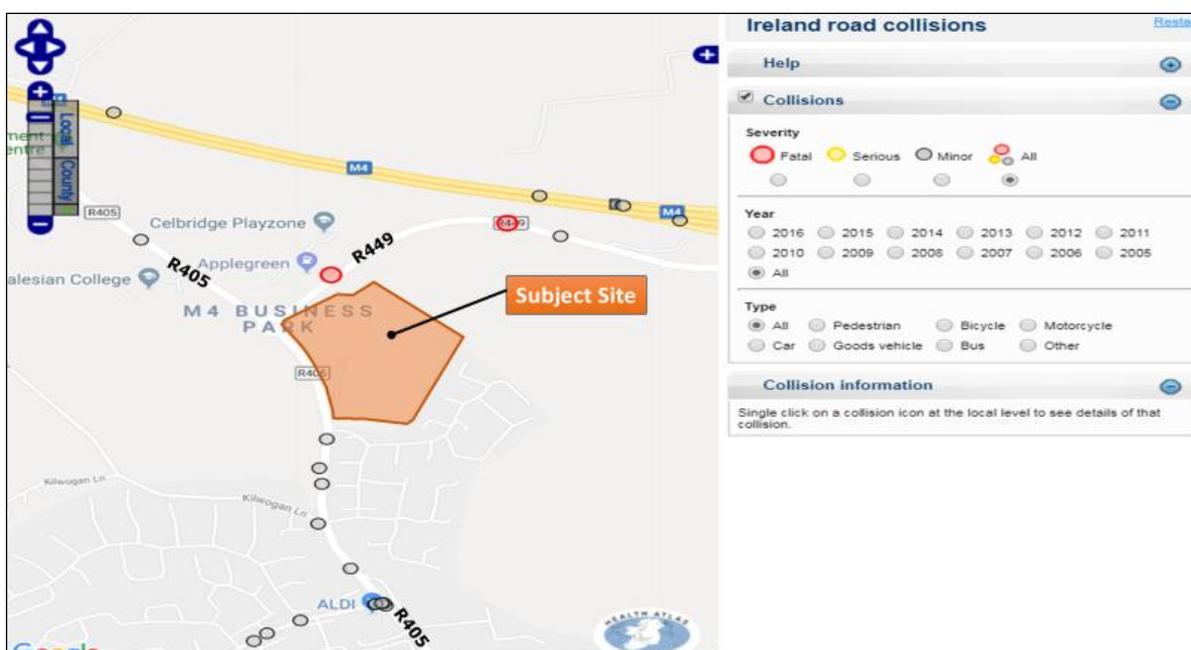
**FIGURE 1.4: RSA Collision Data (www.rsa.ie)**

1.1.13 According to the RSA data there have been three minor collisions within 500m of the proposed development entrance along the Maynooth Rd (R405). There have been one minor and two fatal collisions along the M4 link road (R449). One of the fatal collisions included a pedestrian and the other fatal collision involved a head-on conflict. Figure 1.4 below illustrates the general locations of collisions in the vicinity of the subject site.

1.1.14 In summary the review confirms that no significant incident trends or significant safety concerns are evident across the local road network in the immediate vicinity of the proposed development site access junction on the Maynooth Road corridor.

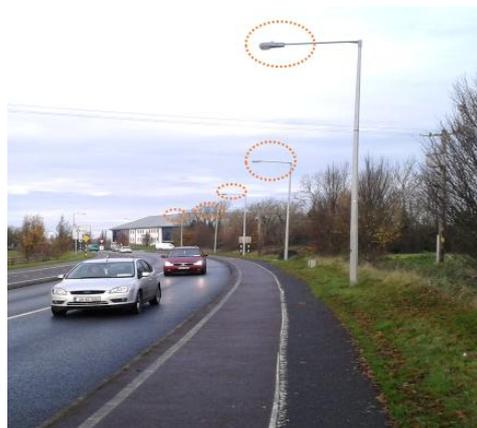
#### 2.1.1 Location (G1) – Lighting

The drawings provided for the purpose of this Road Safety Audit do not provide any details in regard to the provision of street lighting. As a result, the auditors cannot comment upon the adequacy of the proposed street lighting.

However, the auditors noted during the site visit that lighting columns are currently present along the north-eastern side of the Maynooth Road in immediate vicinity of the proposed development site access. As the audit was done during daytime, the lights were not operational during the site visit.

It is noted that the widening of the existing road carriageway on the Maynooth Road will require the relocation of a number of these street lighting columns.

It is unclear whether the proposed site access junction will be sufficiently lit in the hours of darkness. Any reduction in the level of street lighting could contribute to either (i) vehicle drivers not observing the cyclists resulting in a conflict and (ii) increase likelihood of a trip incident for pedestrians. Perceived security levels could also be compromised by poor streetlight conditions.

The scheme designers should ensure that the appropriate level of illumination is provided for through the proposed site access junction and across the immediate approaches and internal streetscapes, footpaths and cycle tracks / lanes.

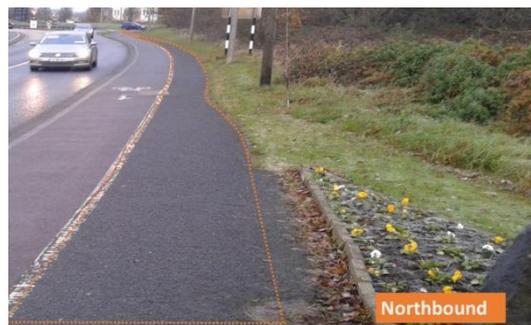
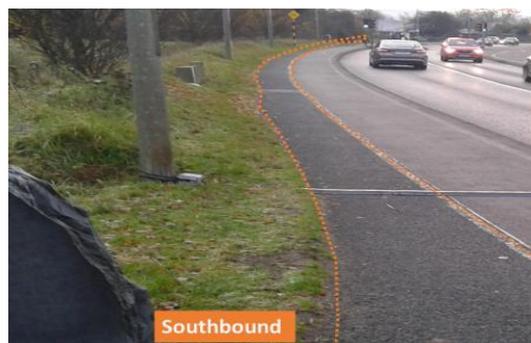
#### 2.1.2 Location (G2) – Width of Existing Footpath (North-eastern Side of Maynooth Road corridor)

The Audit team noted that the existing footpath along north-eastern side of the Maynooth Road corridor exhibits a varying substandard width in places below the recommended levels. The available width of the existing footpath becomes narrower due to the encroachment of the adjoining grass verge that has over recent years encroached into the footpath.

As a result of the inadequate width, pedestrians are required to walk on the adjacent cycle track. This could lead to conflicts between pedestrians and cyclists as there is increased pedestrian and cyclist movement particularly during school peak hours.

The designers should ensure that (i) an appropriate width is safeguarded along all new footpaths being proposed as part of the scheme proposals, and (ii) that the existing footpaths being retained on both sides of the Maynooth Road corridor (along the site frontage) are subject to a maintenance regime that removes the grass that has grown over the sides / edges of the existing footpaths with the objective of making the full as-built width of the footpath available for pedestrians.

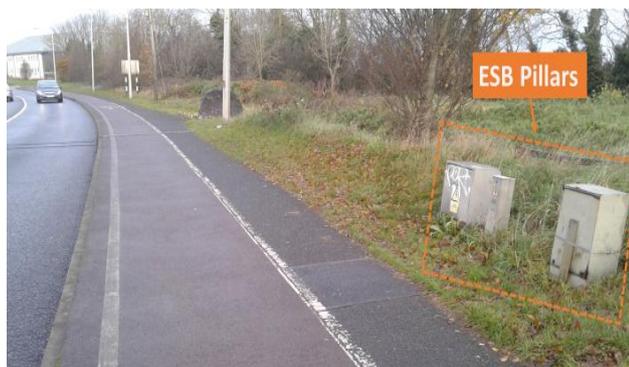
### 2.2.1 Location (S1) – ESB Pillars and Cabinets

During the site visit the auditors noted that there are currently two cabinets located in the general area of the proposed site access junction. There are no details provided on the

drawings presented for the purpose of this RSA in regard to the continued need / retention or relocation of these existing cabinets. The scheme proposals should consider the need for retaining / relocating these cabinets and ensure that any new location as part of the subject junction works do not impede road uses or give rise to conflicts / accidents both during the development's initial construction and subsequent operational stages.

It is recommended that the designers confirm the need to retain / upgrade the existing cabinets and if being relocated they should be positioned where they will not adversely impede road users or the safe operation of the local road network.

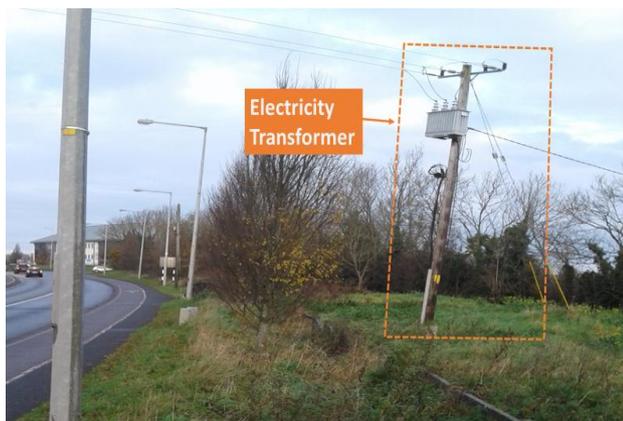
### 2.2.2 Location (S2) - Electricity Pole / Transformer / Pylon

The auditors have noted that there is an existing electricity pole and distribution transformer in proximity of the proposed site access junction. There are no details provided on the scheme drawings presented for the purpose

of this RSA in regard to the continued need / retention or relocation of this electricity pole. The scheme proposals should consider the need for relocating this electricity pole / transformer and ensure that any new location as part of the subject junction works do not impede road uses or give rise to conflicts / accidents both during the development's initial construction and subsequent operational stages.

It is recommended that the Electricity Transformer / Pylon to be relocated to an appropriate position where it will not adversely impede road users or the safe operation of the local road network during the development's initial construction and subsequent operational stages.

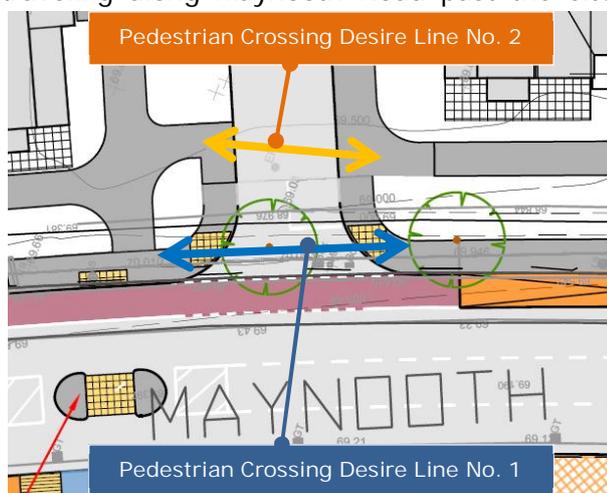
#### 2.2.4 Location (S4) – Minor Side Road with Pedestrian Priority

The auditors noted during the site visit a notable volume of pedestrians walking along the existing pedestrian footpaths as located on both sides of the Maynooth Rd corridor and traveling to/from destinations located to the northwest of the subject site (including schools and business park facilities).

The design of the proposed site access junction incorporates a traditional configuration that affords a higher priority to vehicles entering / exiting the proposed development and thereby requiring pedestrians (traveling along the main arms of the junction) to cross the minor arms road carriageway (by way of tactile paving and dropped kerbs). It is also noted that a 'second' potential pedestrian crossing desire line (across the minor arm of the junction) is evident approximately 6m back into the site and parallel to the main arm's pedestrian footpaths.

In the context of (i) a single vehicle access being proposed to serve the entire residential development (subsequently influencing the number of vehicle movements into / out from the junction's minor arm), (ii) the number of pedestrians (and potential vulnerability of these pedestrians e.g. school children) possibly crossing the minor arm of the junction, (iii) the presence of a 'second' pedestrian desire line immediately within the site, and (iv) the observed speed of vehicles traveling along Maynooth Road past the site (particularly southbound vehicle drivers which may influence the speed of vehicle turning into the subject site from the Maynooth Rd) the auditors are concerned that the potential for conflicts between inbound moving vehicles and pedestrians is increased.

It is recommended that both pedestrian desire lines (across the minor arm of the site access junction) are amalgamated into a single crossing facility that is set back within the site 5m and benefits from the provision of a flat table top ramp and tactile paving thereby affording pedestrians enhanced priority in addition to slowing vehicle speeds at the potential conflict point. This approach also provides an entrance feature into the slower speed environment within the proposed residential development. Consideration should also be afforded to tapering the Maynooth Road kerbside footpath (as located either side of the proposed minor arm) from its kerbside location to the new crossing point location thereby encouraging pedestrians to cross the minor road at the appropriate location.

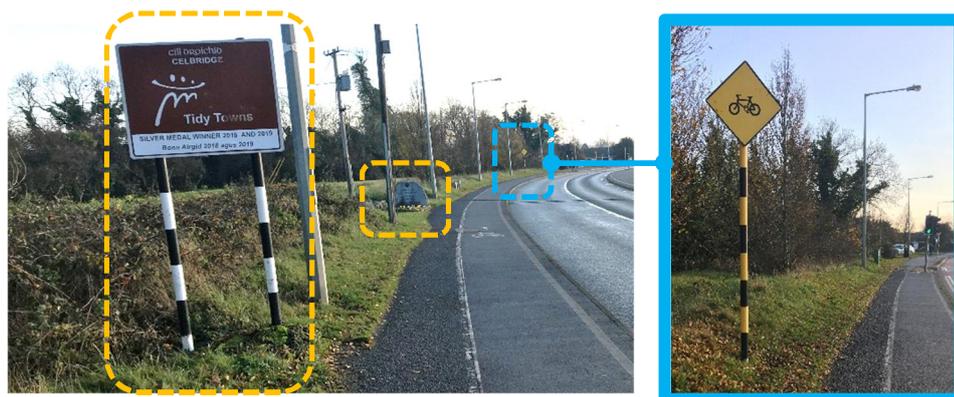
### 2.2.11 Location (S11) – Existing Street Furniture and Advance Warning Signs

Existing street furniture in the form of signage (Tidy Towns and Cyclists Warning signs) and town entrance feature (Stone name plate) are required to be relocated to accommodate the proposed site access junction works.

The auditors are concerned that if the proposed junction design does not take due consideration of these existing features local stakeholders may seek to retrofit them to the completed scheme (upon completion of subject construction works). In such situations they may be located within

inappropriate locations where that may constitute a hazard to road users including cyclists and pedestrians.

It is recommended that the scheme designers undertake an audit of all existing street furniture impacted by the proposed works (and on the immediate approach to and from along Maynooth Rd) and identify which features are to be removed completely or relocated (in appropriate locations) as part of the subject development works.

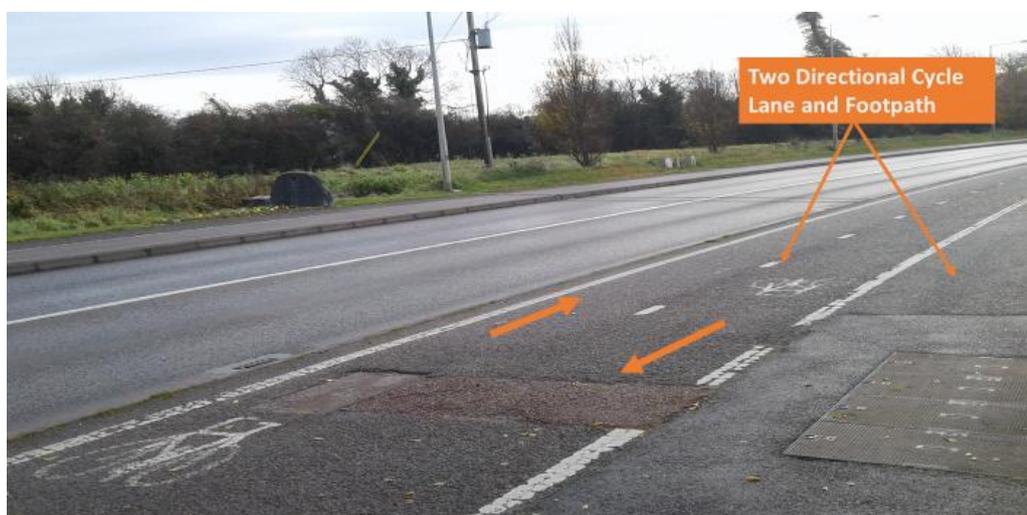
#### 3.1.1 Location (C1): Pedestrian and Cycle Facility on the of the Maynooth Road Corridor

As illustrated below there is a two-way cycle track and parallel footpath currently provided along the southwestern side of the Maynooth Road corridor opposite the proposed site access junction.

During the site visit the auditors observed that the cycle track and pedestrian footpath surface had a number of deformations which represent a hazard for both cyclists and pedestrians. It is recommended that the local authority is made aware of these existing deficiencies with the objective of programming appropriate maintenance works as soon as the opportunity arises.

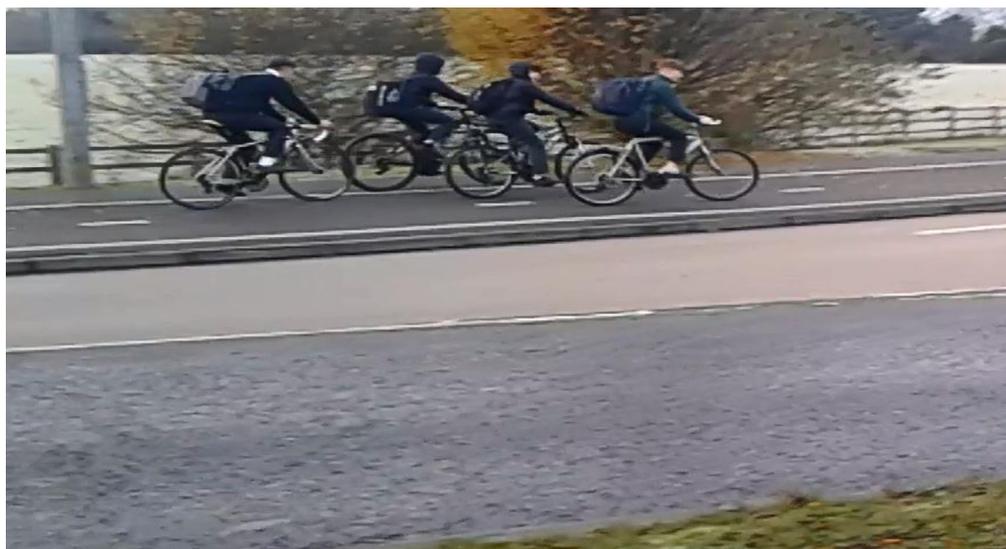
During the site visit the auditors observed that many students were both walking and cycling to / from the local school / colleges using these existing facilities. The auditors noted that many of these cyclists travelled in groups of up to 4 or 5 and were observed using both sides of the two-way cycle track and the adjoining pedestrian footpath. This practice made it both difficult and uncomfortable for pedestrians who very much felt threatened (feel of being in a collision) by the groups of cyclists using the pedestrian footpath.

These existing practices should be monitored by the local roads authority with consideration being given to the need to retrofitting appropriate control measures with the objective of guiding cyclists to use the cycle tracks, segregating users and subsequently enhancing safety levels for pedestrians
